TITUSVILLE, PA

DESIGN GUIDE FOR HISTORIC STRUCTURES & FEATURES

Published: November 1, 2018

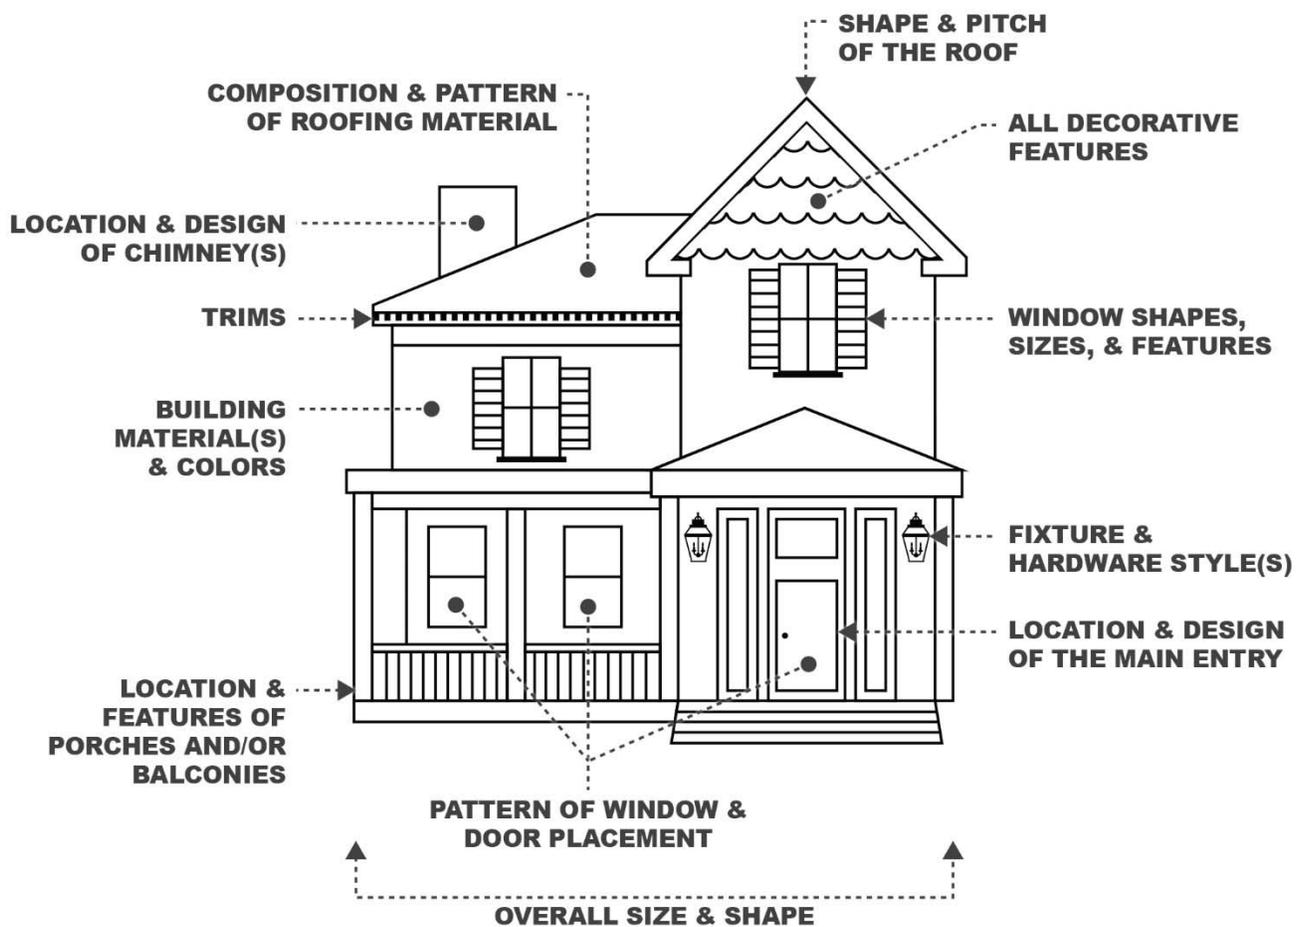
The diagram below serves as a visual aid to assist in determining the character-defining features of a building.

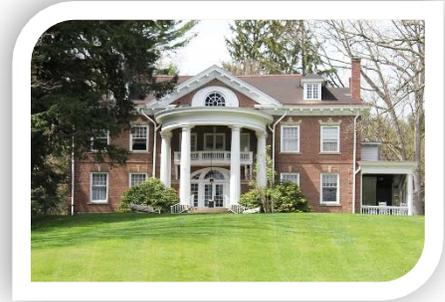
Hillhurst Bed & Breakfast |
701 N. Perry St.

The Georgian style originated in 18th century England and was the first architect-inspired style in the United States arriving via British architectural pattern books. The Georgian style reflected a period of colonial growth and a desire for more formally designed buildings in the new colonies. Buildings in this style typically include homes, schools, and courthouses. Georgian buildings are usually characterized by the use of stone or brick materials and have a symmetrical form, side-gabled or hipped roof, paired chimneys, cornice with dentils, multi-pane windows (six to 20 panes of glass in each sash), and a water table or belt course (a continuous row or layer of stones or brick set in a wall). The front entry is usually centered with an elaborate portico.

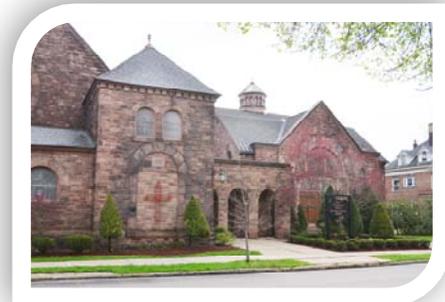
First Presbyterian Church and Emerson
Chapel | 216 N. Franklin St.

The Romanesque style was introduced to the United States in the mid-19th century, as buildings based on ancient Rome grew in popularity. The influential American architect Henry Hobson Richardson adapted the style in the 1870s and 1880s, developing a more dramatic version of the style that became known as Richardsonian Romanesque. The Romanesque style was used for homes, brownstones, schools, churches, government offices, banks, and commercial buildings. This style has a massive, and strong appearance formed in part by heavy masonry building materials such as stone, brick, and marble. Characteristic features include thick walls, large windows and doors, arched windows and rows of arched features (arcades), towers, polychromatic stonework on details, and sturdy pillars and columns.

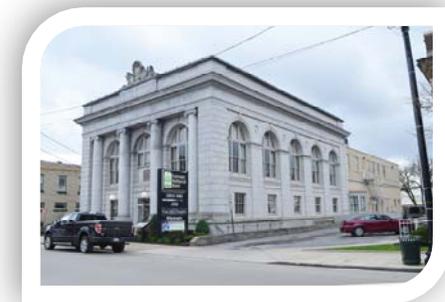
Titusville Trust Company |
127 W. Spring St.

The Beaux Arts style originated in France and is derived from *Les beaux arts* (the fine arts). It gained popularity in the United States in the late 19th century after the 1893 Columbian Exposition in Chicago in 1893 and due to an increase in American architects studying abroad in France. This style developed in places like Titusville where turn-of-the-century affluence was concentrated and was seen as an ideal expression of both corporate wealth and civic pride. Buildings in this style typically include court houses, post offices, banks, schools, libraries, offices, churches, and mansions. Beaux Arts buildings are characterized by their grand and imposing size and scale, symmetrical façade, and classical

Greek and Roman decorative elements like columns, pediments, quoins, balustrades, and wall surfaces with garlands, floral patterns, or shields. These buildings have flat or low-pitched roofs, pedimented or arched windows, and are generally perceived as formal or monumental in style.

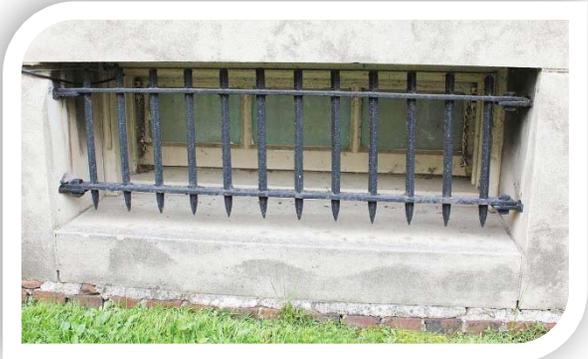
ATTRACTIVE FOUNDATION OPENINGS

- ↻ 1.4 Keep ventilation openings in the foundation clear. Existing ventilation openings should not be filled. If the design of the ventilation cover (also called a “grill”) contributes to the architectural style of the building, maintain the original design if feasible. In Titusville, many foundation opening covers are made of cast iron or other decorative metal and contribute to the building’s character. Replacement covers and parts can often be found online.

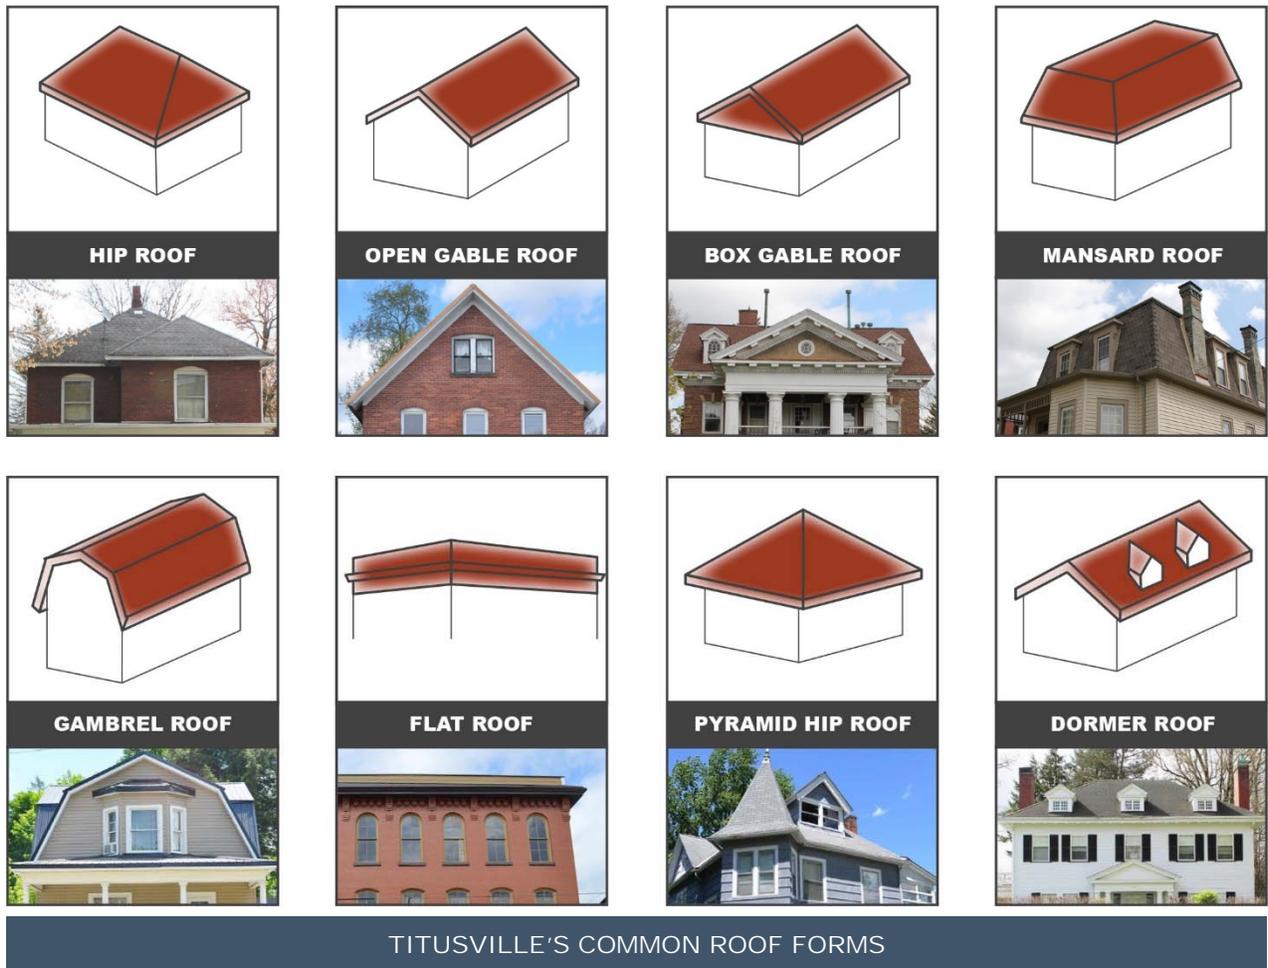
The Most Common Roof Forms Found in Titusville are:

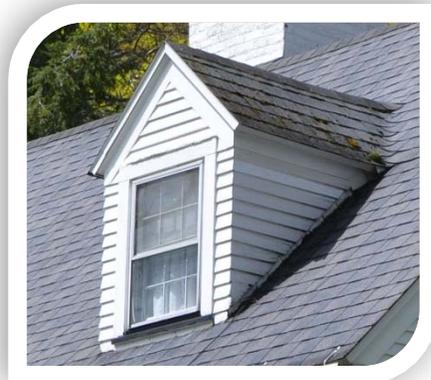
DORMER WINDOWS

Preserve dormers (a structure with window projecting from the roof) whenever possible. If dormers are severely damaged and must be removed, replacing them with a new dormer is preferable over removing the dormer entirely.

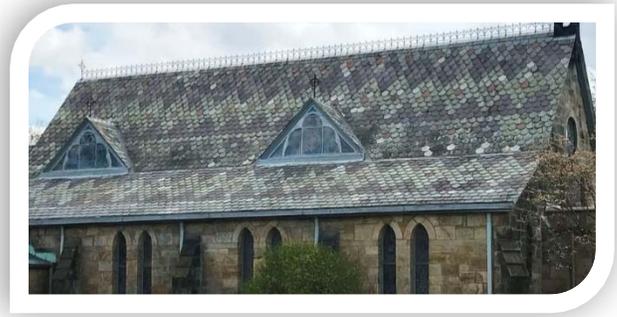
HISTORIC ROOF MATERIALS

Historic roofing material, such as this slate tile roof on the Saint James Memorial Episcopal Church, substantially contributes to historic character.

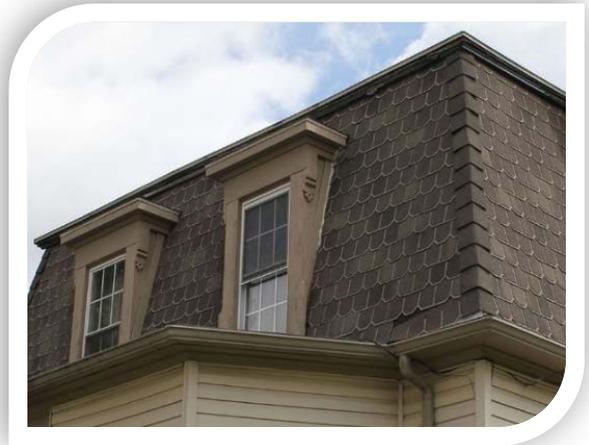
REPLACEMENT MATERIALS

The original mansard style roof materials on this home were replaced with material that replicates the style of the historic roof materials.

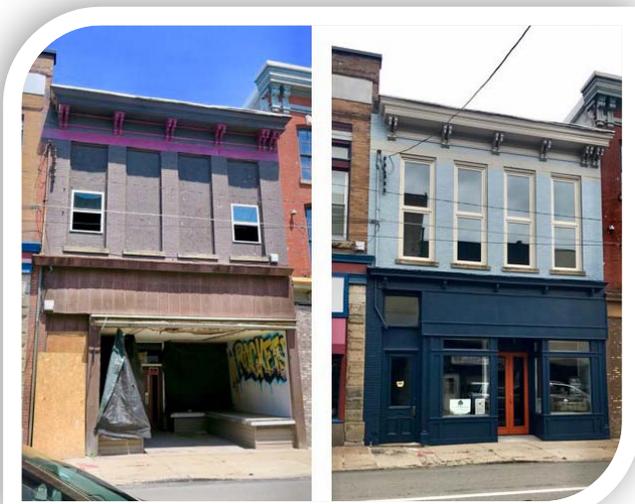
WELL-DONE WINDOW REPLACEMENT

Example of a well-done window replacement project. Photo on the left shows historic large window openings boarded up and replaced with small modern windows. Photo on the right shows beautification of the building with properly sized and designed replacement windows.

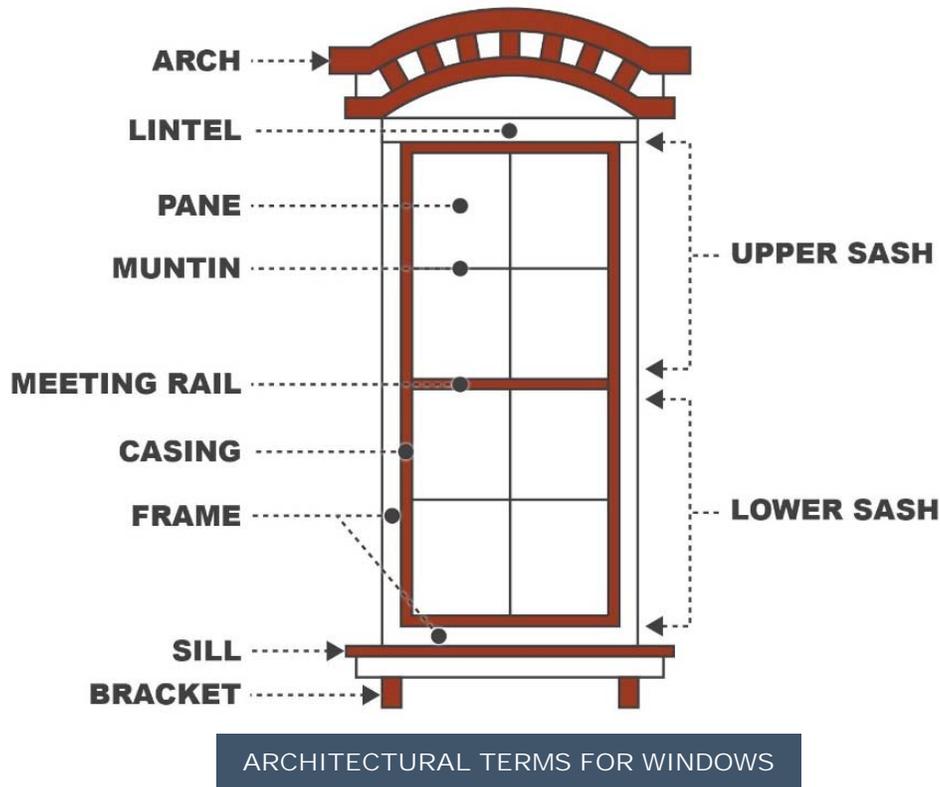
The window guidelines presented herein give recommendations for preserving, repairing, and replacing historic windows by using methods that avoid awkward patch-work while also respecting the architectural character of the historic building stock. The recommendations use architectural terms related to window composition, shown here for reference.

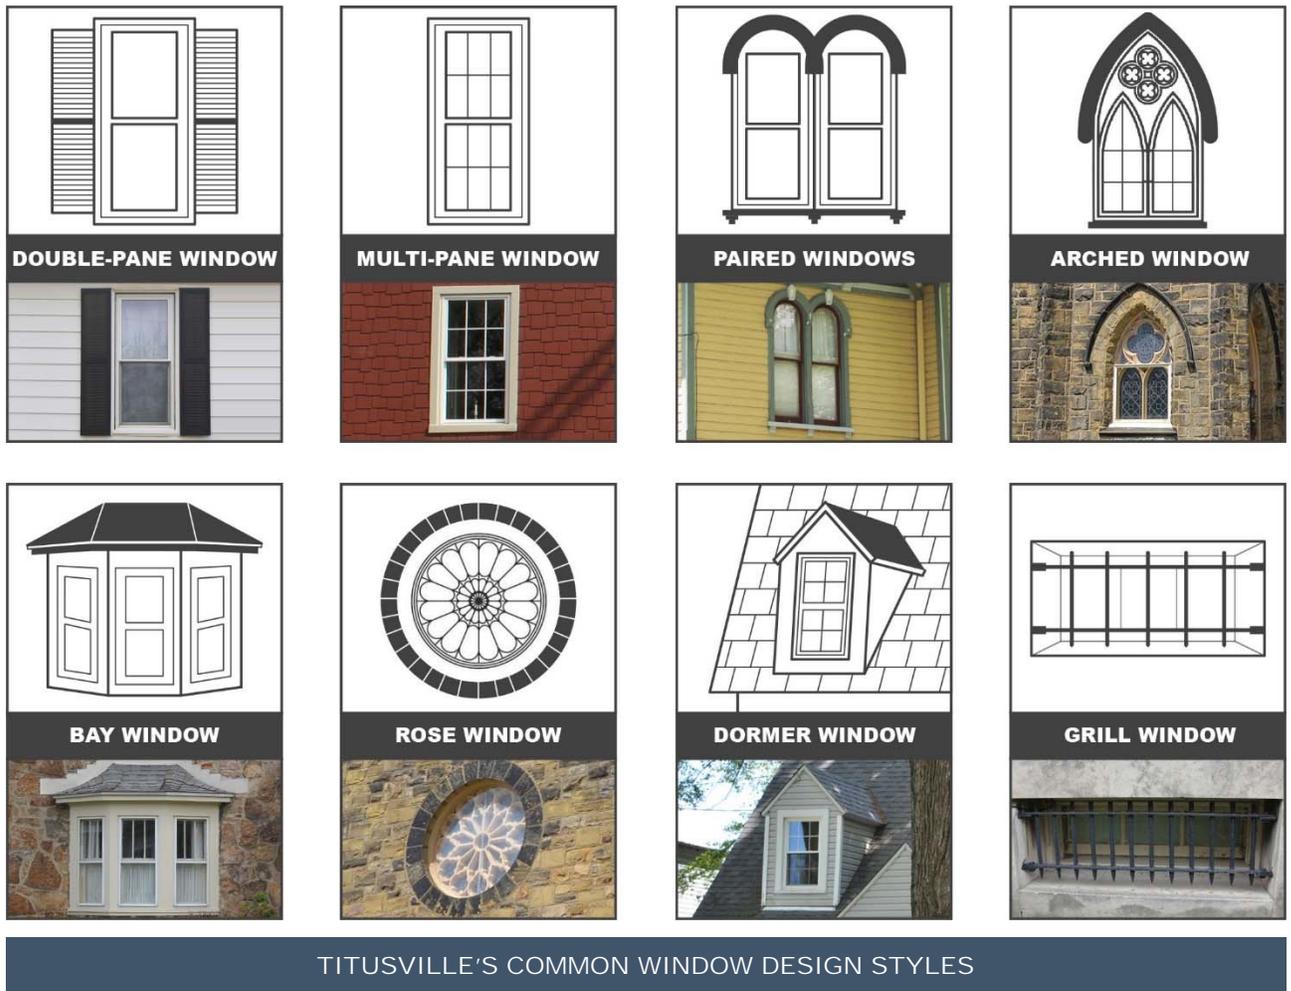
Shown below are the most common window design styles found on historic structures in Titusville.

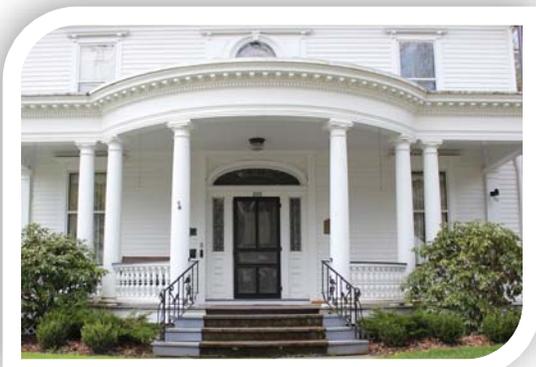
ORIGINAL FRONT DOOR DESIGN

The Byron Benson House retains its original front door design, which complements the home’s tall first floor windows and clapboarded exterior finish.

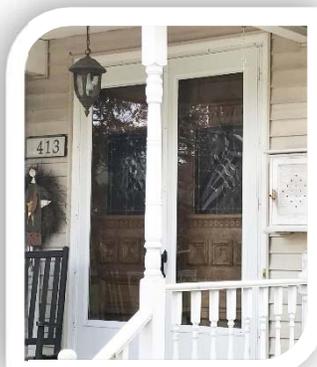
CLEAR STORM DOOR

Storm doors installed with single clear glass panes allow views of these original wood doors seen on N. Perry Street.

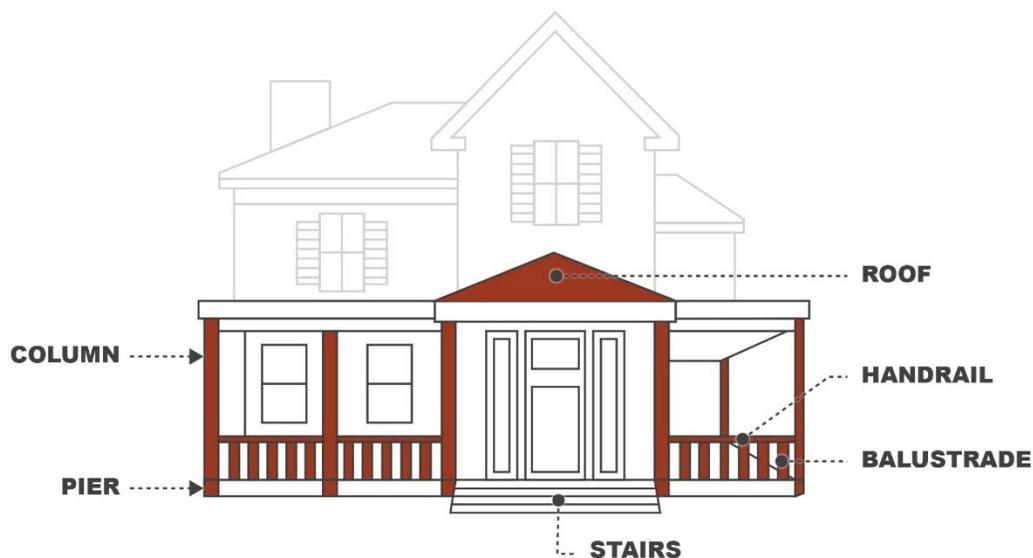
ARCHITECTURAL TERMS FOR PORCHES

The recommendations given below use architectural terms related to porch and balcony design, which are shown below for reference.

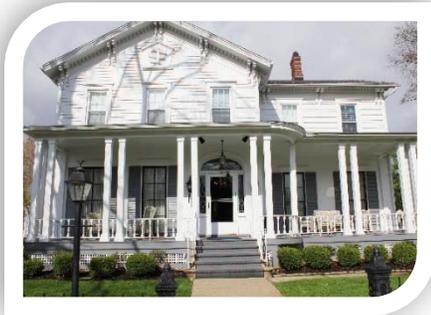
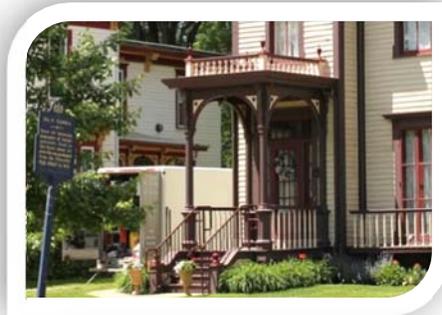
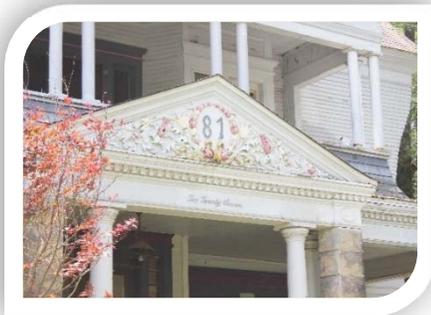
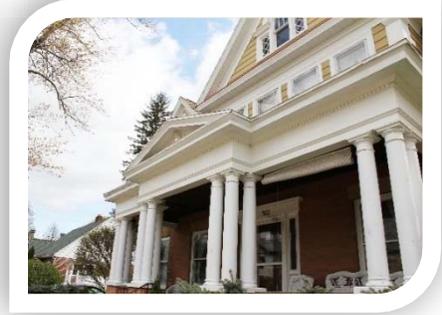
TRADITIONAL PORCH AND BALCONY FEATURES

Traditional porch and balcony features accentuate the various historic architectural styles found throughout the Titusville National Register Historic District. These classic examples are found on N. Washington Street, E. Main Street, W. Main Street, and N. Perry Street. On the Tarbell house (top right), the front porch and veranda are replicas, and the metal railings on both sides of the porch stairs were designed for compatibility with the structure’s architectural style and color palette.

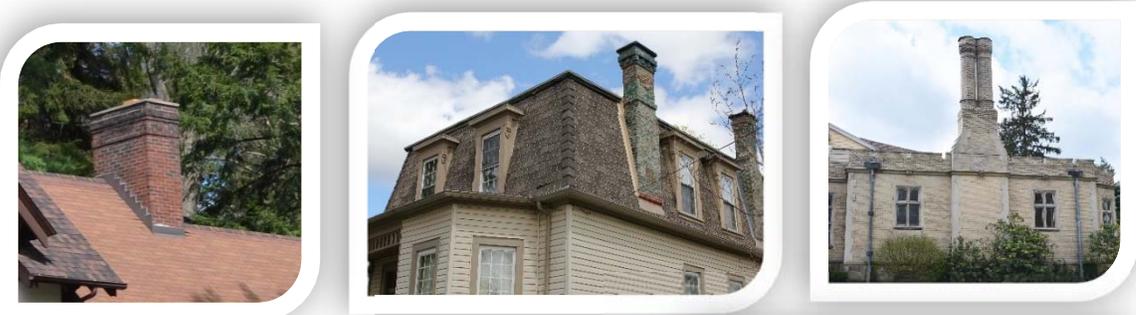
CHIMNEY DESIGN

Single and multiple chimneys are found on many of Titusville’s historic structures. The chimney on the William Scheide House (top right) was part of a 1920s addition to the structure.

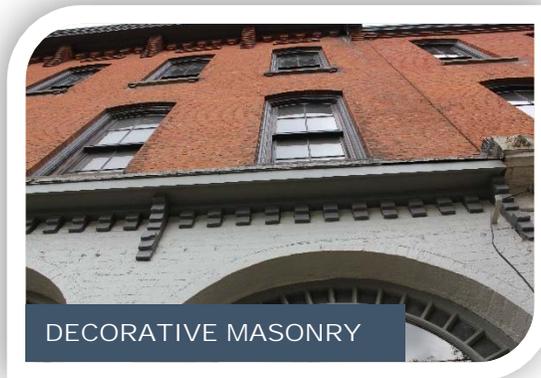
Decorative masonry features are found on this brick building, including arches, dentils, brackets, and cast masonry accents.

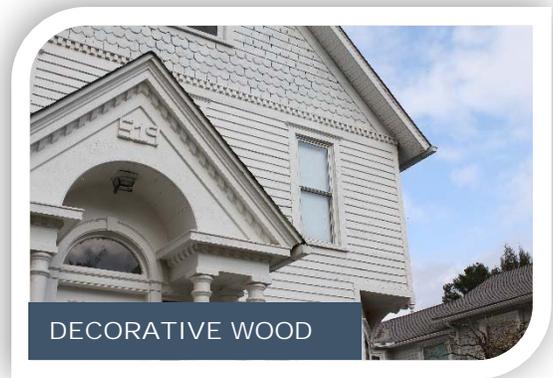
Decorative wood features are found on this wood clapboard home, including fish scale shingles, columns, and dentil moldings.

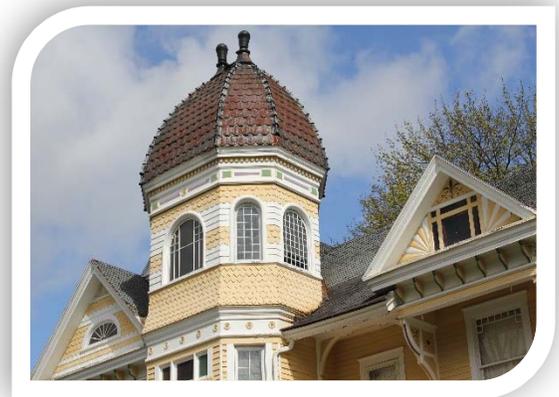
ROOFTOP PROJECTIONS

An example of a well-preserved cupola on a Queen Anne style home found on W. Main Street.

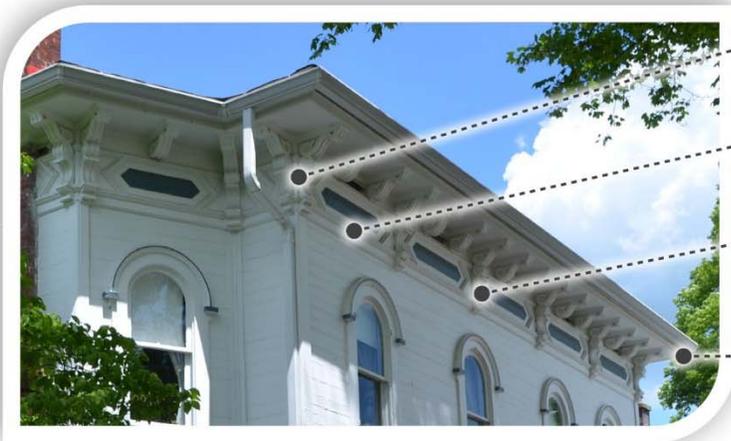
This section addresses the most common decorative features found on Titusville’s historic buildings. There are many more types of architectural enhancements and embellishments than those highlighted herein, all of which add to the overall historical sentiment of the building. Although not all of the possible enhancement features are mentioned below, all structures should be closely examined with the intention of preserving the decorative features that showcase its craftsmanship. Unlike most modern structures, countless historic buildings in Titusville were custom designed by professional architects and/or closely patterned after a particular, traditional architectural style. The details found on these buildings are incredible, and would be difficult—if not impossible—to replicate using modern construction practices. Provided below are examples of typical decorative features found in Titusville.

Cornice | The horizontal decorative molding that crowns a building, window, or door.

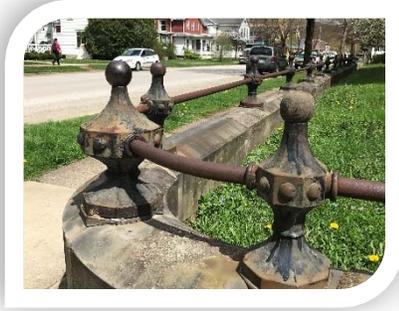
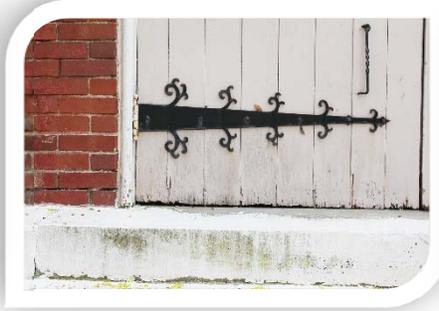
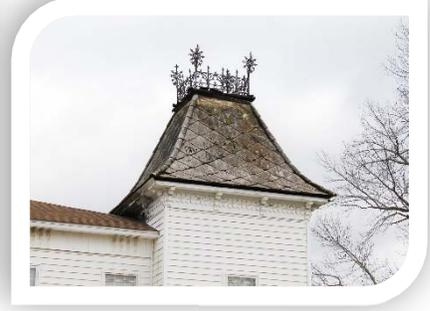
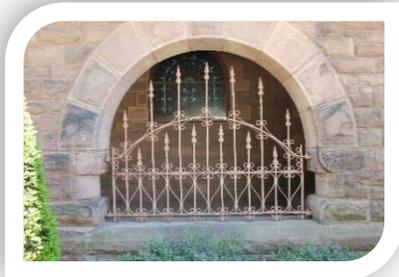
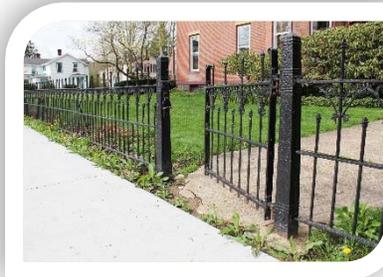
APPLICATION OF DECORATIVE METAL

Historic ironwork and other decorative metals are used for various functional and decorative purposes throughout Titusville. Examples include fences, pillars, railings, window grills, hinges, roof crestings, and even old horse hitches.

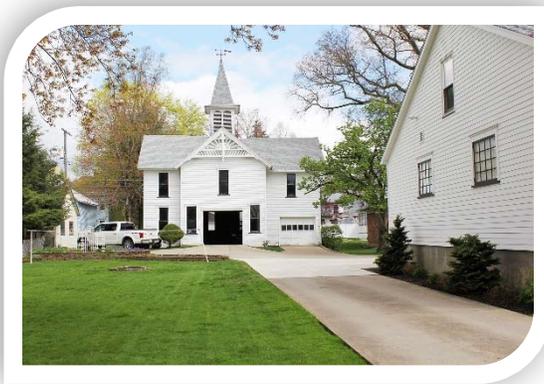
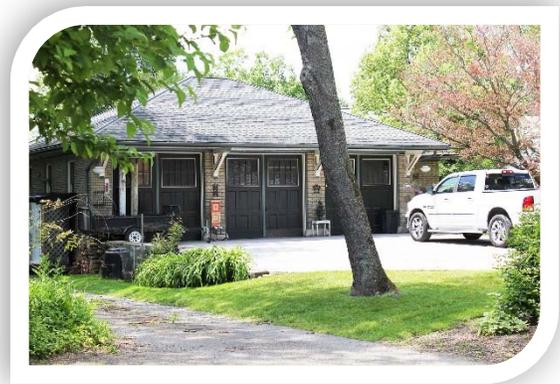
CARRIAGE HOUSES

Example of carriage houses and historic garages adapted for modern use.

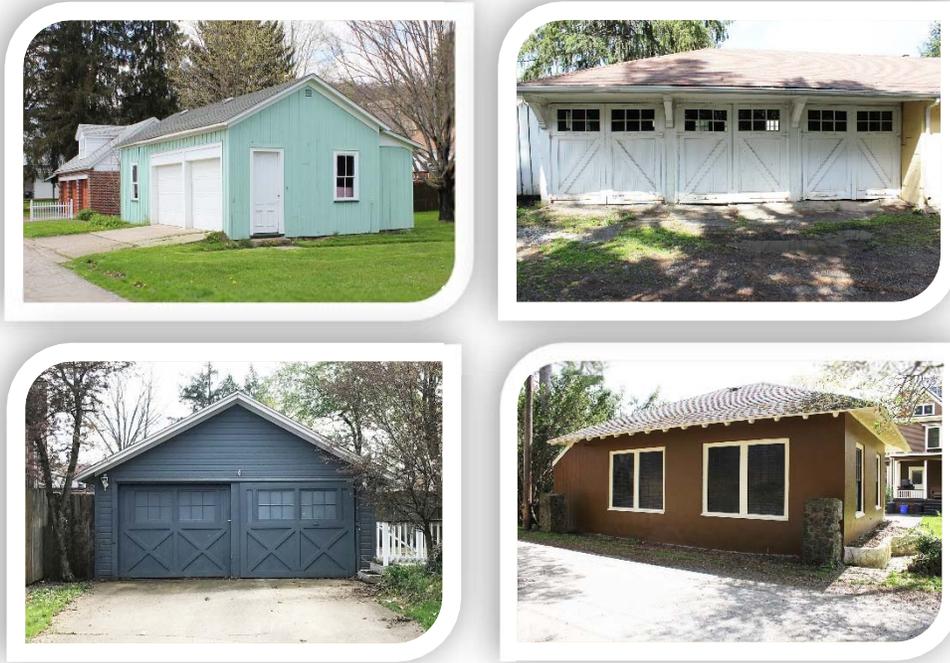
GARAGE DESIGN

Examples of garages with design features that are characteristic of a traditional architectural style.

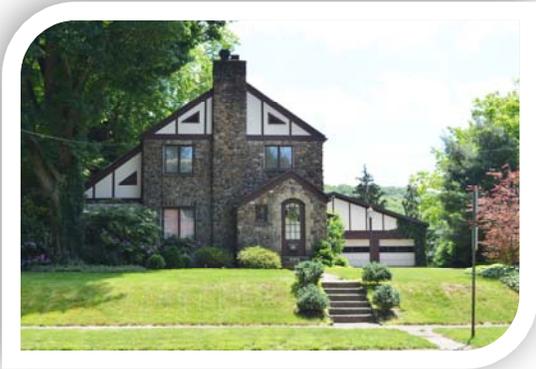
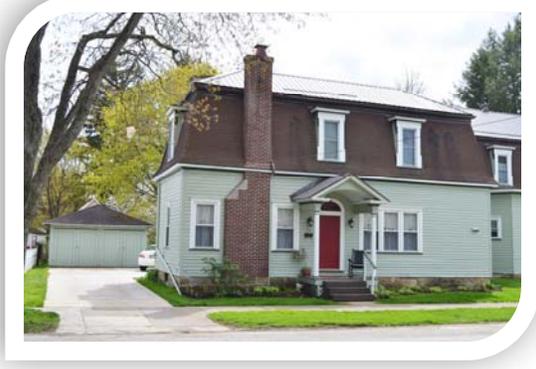
GARAGES APPEAR SUBORDINATE TO THE PRIMARY STRUCTURE

Examples of garages that are set back from the main house, subordinate in appearance, yet comparable in terms of color and design. This practice is recommended.

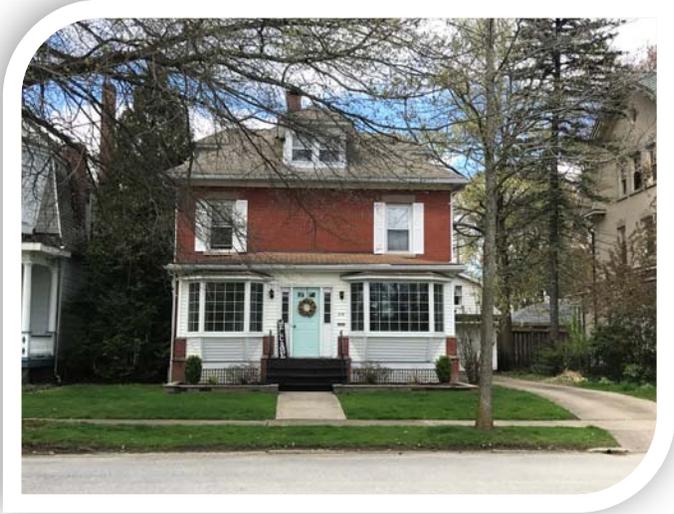
SINGLE LANE DRIVEWAYS

Driveways should be a single lane wide as viewed from the street.

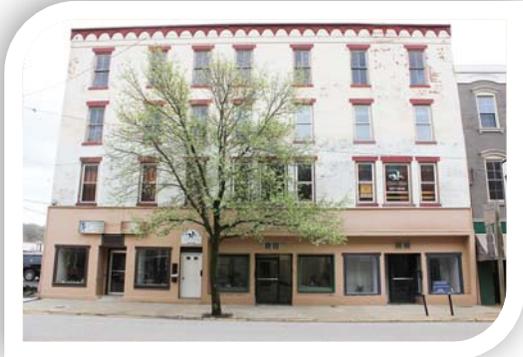
PATTERN OF OPENINGS

Notice the vertical and horizontal pattern formed by the lower façade, upper façade, and window and door openings on this S. Franklin Street structure. Changes made to the pattern would disrupt the visual rhythm not only on the building itself, but also the pattern formed by any adjacent buildings.

**5.1** Before undertaking changes to a commercial building, consider the overall horizontal and vertical patterns in the building design, including the placement pattern of the doors and windows in relation to buildings adjacent and on the same street. Strive to maintain the strong vertical and horizontal rhythm presented by the placement and size of windows, doors, and architectural features in relation to nearby structures. Do not introduce new patterns or forms that break or change the existing vertical and horizontal patterns. Preservation of the traditional horizontal and vertical patterns in a building and among adjacent buildings in the same block is the most critical design issue facing Titusville’s commercial core.

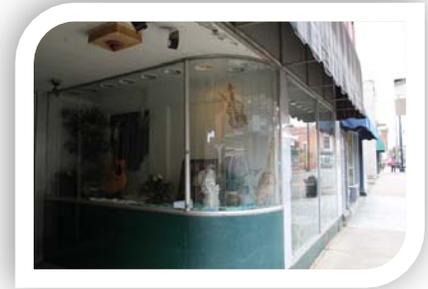
DISPLAY WINDOWS

Display windows create an inviting and welcoming environment for pedestrians and customers at commercial storefronts. The original curved glass display window shown above was replaced with multiple panes that achieved the curved appearance.

5.3 Transparency from the sidewalk to the interior of the ground floor through glass doors and display windows is a traditional and character-defining feature of the commercial district. Make sure to preserve display windows. Do not remove, permanently cover, or brick them in. If privacy of the building occupant is desired, cover display windows from the inside while keeping the glass intact and visible from the outside. If display window glass needs to be replaced, strive to replace it with similarly-sized large pane glass. If the pane size cannot be matched, or if the original curvature of the glass cannot be replicated, simulate the size and shape by using multiple panes, but with as few as possible.

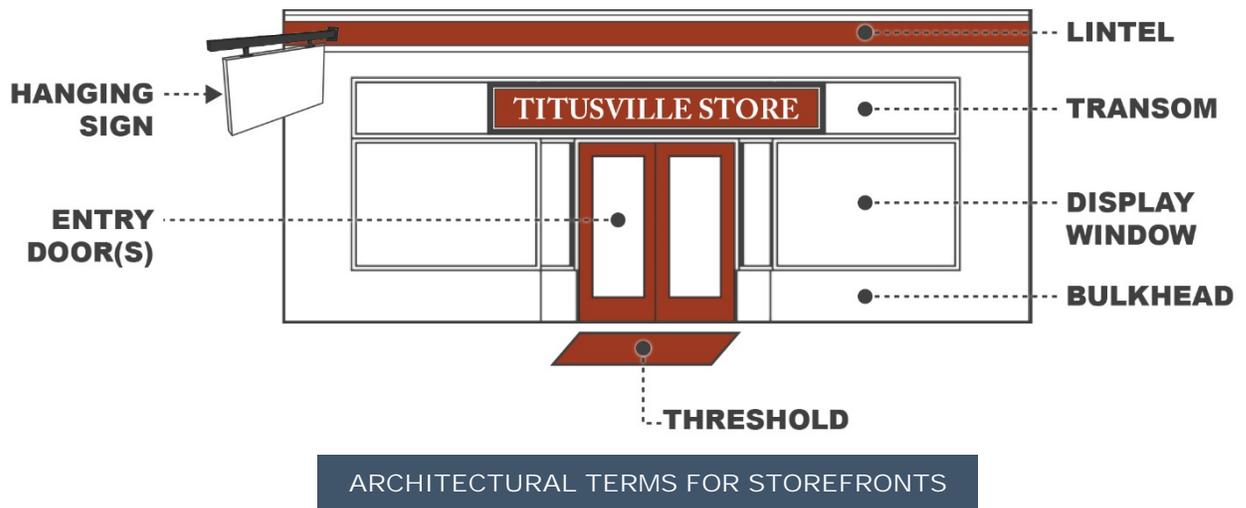
5.4 If the original storefront is too deteriorated to repair, replace it with a contemporary storefront design that is highly compatible with the rest of the building in terms of scale, architectural style, window and door patterns, materials, and color scheme. Design the new storefront to look “new” while not drawing attention away from the historic architectural details found on other portions of the building. The storefront should be obvious by having the traditional features of an original, such as recessed entry doors, transparent doors and display windows, transoms, bulkheads, a lintel between the lower façade and upper façade, etc. (see the diagram below).

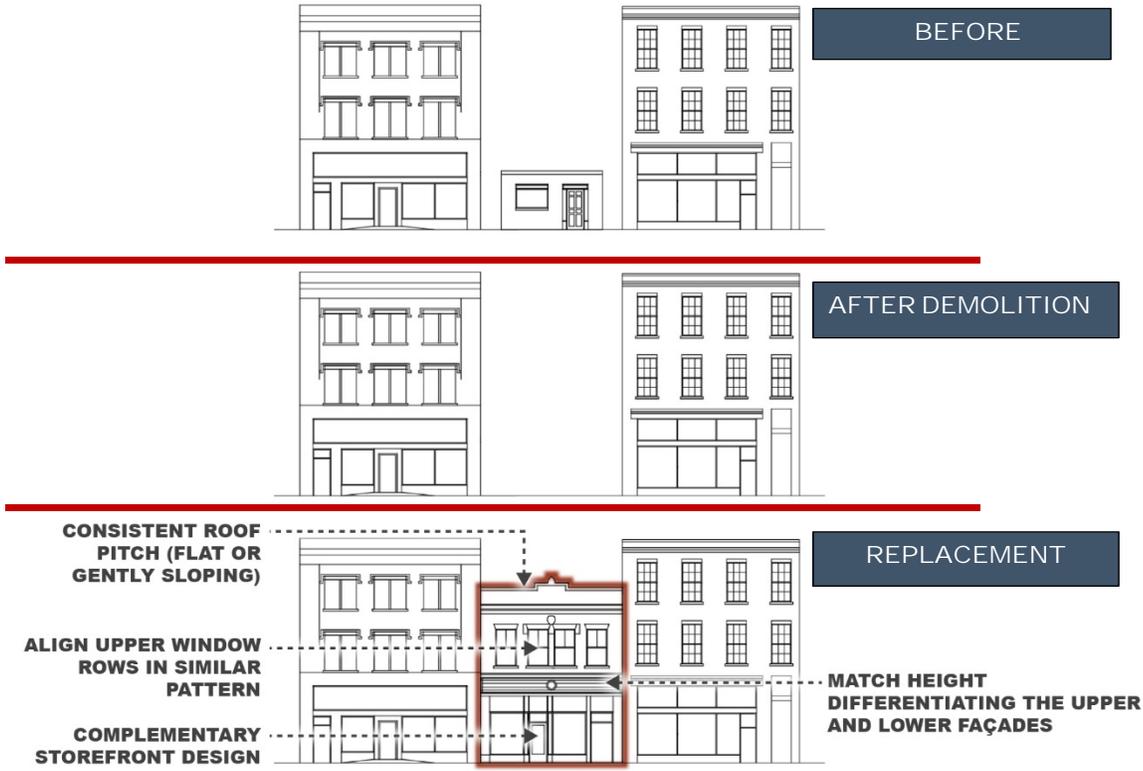
6.14 In the commercial district, design new buildings to follow the rhythm and scale of existing adjacent buildings. As shown in the diagram below, new commercial building construction should be the same height and no more than one story shorter or taller than immediately abutting structures. Also, match the roof pitch (typically, flat or gently sloping); steeply sloped roofs are incompatible with the character of commercial buildings in the central business district unless used on a purposeful architectural embellishment such as a tower. One-story buildings are strongly discouraged when placed immediately adjacent to taller buildings.

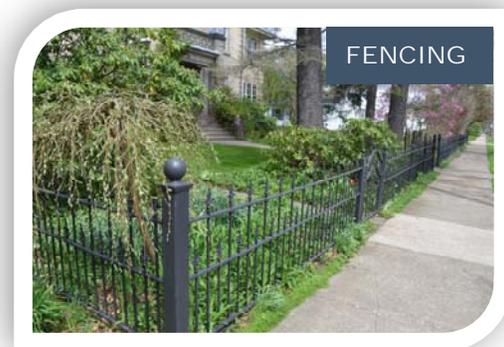
The cast iron fence is characteristic of the Victorian Garden landscape style and an integral component of Titusville’s landscape character.

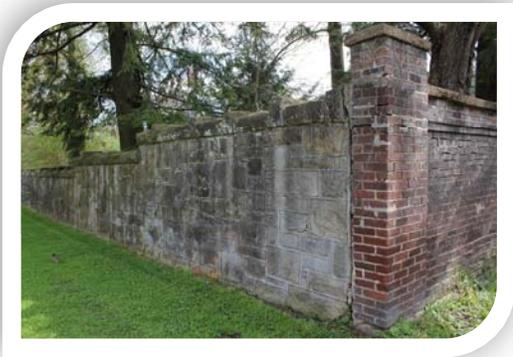
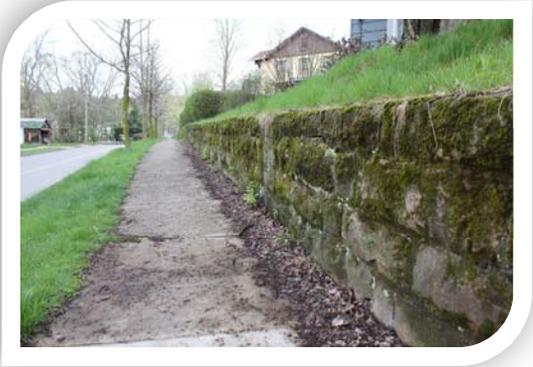
MASONRY WALLS

Cast stone, brick, and other masonry are showcased here in a freestanding wall and retaining wall.

7.7 Masonry walls and pillars are a common sight of the Titusville landscape. Preserve and repair, rather than replace, these historic features.

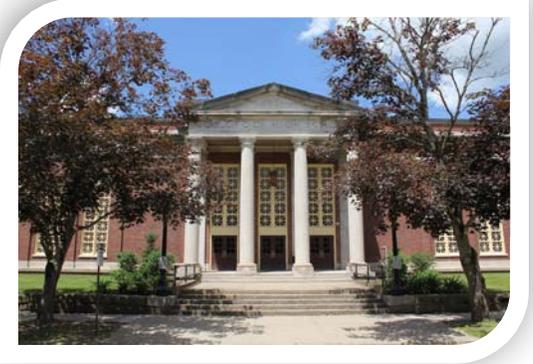
TREE PLACEMENT

Plant trees to the side of building entrances and away from structure foundations to avoid root damage and tree litter on the building’s roof.

7.9 Avoid planting trees directly in front of a building’s entrance; doing so blocks the view and diminishes the welcoming atmosphere of Titusville. Also avoid placing large trees and plants close to a building; doing so may cause root damage to foundations or basement walls causing them to crack or heave. Further, tree limbs overhanging a building’s roof may promote the growth of plant materials in gutters, particularly if they are not cleaned on a regular basis. Position trees to the side of the front entry and at least three times the distance from the structure as the tree trunk at maturity.

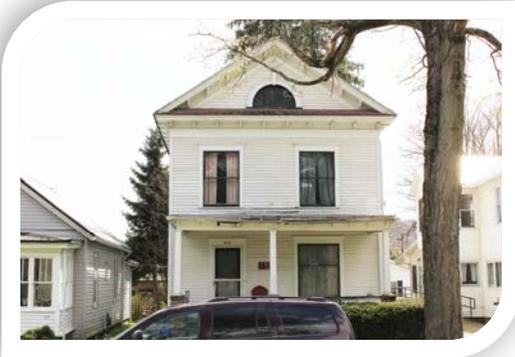
ARCHITECTURAL STYLES

The overall design and architectural details found on this Stick style home located on W. Elm Street, outside of the historic district, visually connect the home and its neighbors to the ambiance of historic Titusville.

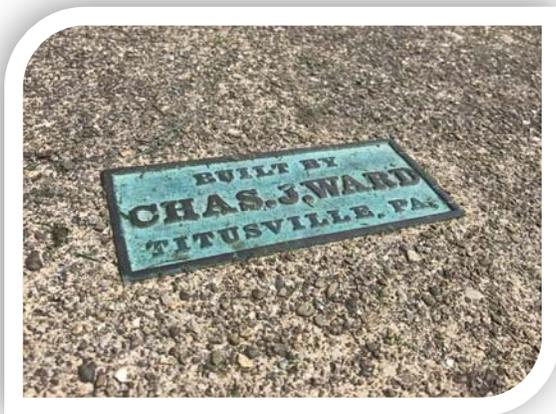
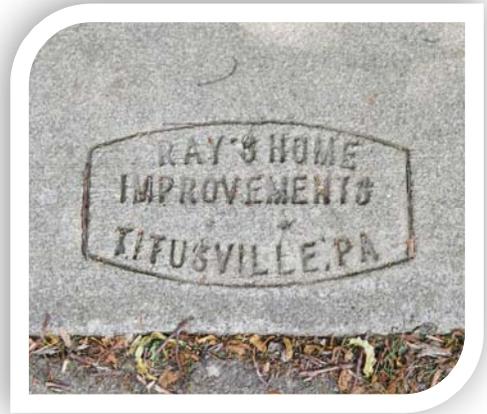
TRADESMEN MARKS

Examples of fabricator markings found in the sidewalk system. Chas. J. Ward (sidewalk inset) and Ray's Home Improvements (sidewalk concrete impression).

8.5 Preserve all historic fabrication markers embedded in the sidewalk system. These are found throughout the community and are a unique interpretive element of interest.

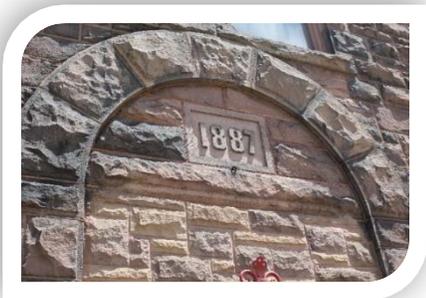
BUILDING DATE MARKINGS

Examples of date markings found in the Titusville National Register Historic District.

- 8.10 Preserve date markers on historic buildings, which supplement interpretation of the city’s historical timeline. If these markings are obscured by vegetation or other obstruction, remove the visual impediment to clearly reveal the marking.
